SANITATION

Seminar points to long road to create safe sanitation for all

Matthew Hattingh reports on the latest sanitation-related research as presented at a seminar hosted by the Water Research Commission in celebration of World Toilet Day on 19 November last year.

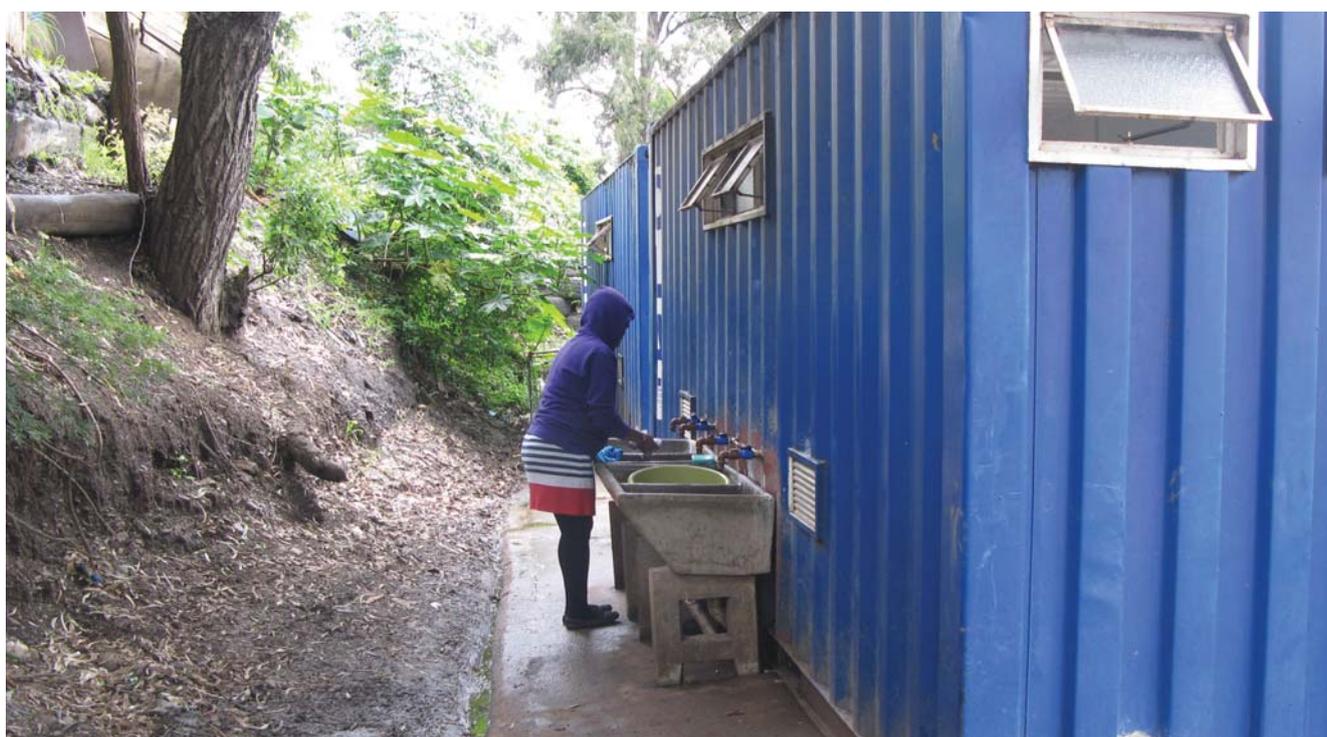
Community ablution blocks, created inside shipping containers, are one of the sanitation solutions that the eThekweni Municipality has implemented.

CABs came on the scene after 2004, first as brick structures. But these took too long to build and suffered vandalism. The municipality later switched to using converted shipping containers and then modular or prefabricated designs. This cut installation and maintenance costs and, as a plus, meant CABs

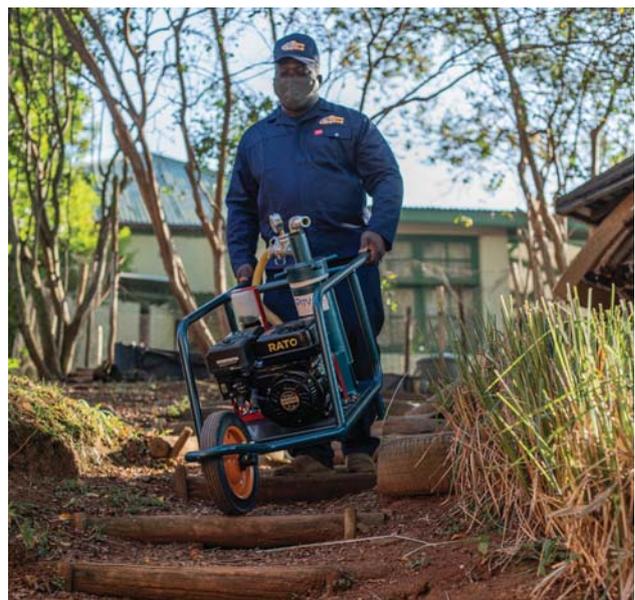
Partners in Development's work with the Sani Squad, a sanitation business in Snathing, near Pietermaritzburg, provides a useful example of how simple, but effective equipment combined with training and good management can help make pit latrine emptying safer.

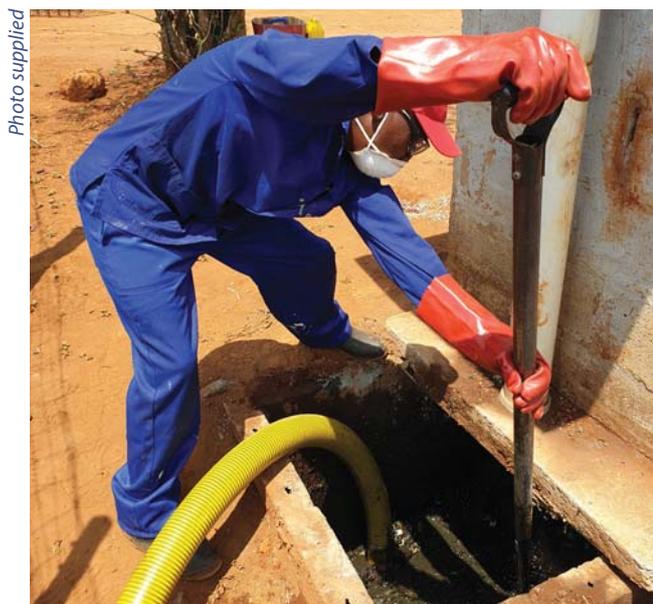
Long-handled spades help Sani Squad workers keep sludge at more than arm's length.

They used a Pitvaq pit emptying machine (developed by PID thanks to WRC research) and other tools, including long-handled spades, groundsheet and sludge drums with lids, to limit worker contact with sludge and to minimise spills. Training, multiple uniforms and personal protective equipment helped further.

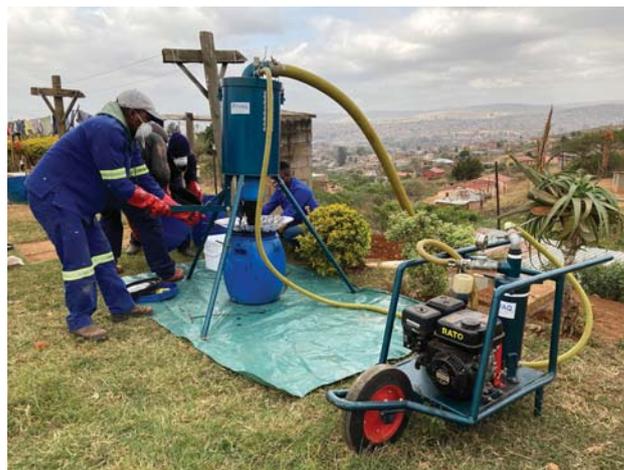
Sani Squad workers use a Pitvaq mobile pit emptying machine to avoid contact with faecal sludge. Groundsheets catch spills, protecting householders and the environment.
